# ARM Facilities Newsletter

ANL/ER/NL-02-09

## Raman Lidar Receives Improvements

## Okmulgee Tower Upgrades

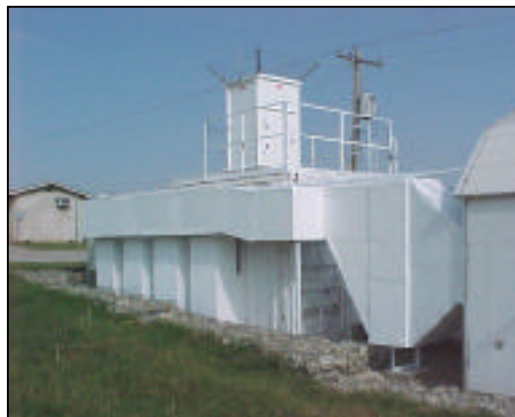
The Raman lidar at the SGP central facility is receiving upgrades to its environmental controls. This ground-based remote sensing instrument uses a laser to measure vertical profiles of water vapor mixing ratio, as well as many cloud and aerosol quantities. The lidar is housed in a shipping container (Figure 1) that has its own heating and air conditioning unit to maintain the stable temperature and humidity levels required by the computer and laser equipment.

Although great care was taken to engineer the appropriate climate controls, problems have occurred over the years. Laser optics are heat sensitive, and the quality of the emitted beam varies if the temperature is not stable. The present air conditioning setup has allowed the optics to cool down when the unit is on and warm up when the unit is off. These thermal changes during air

conditioner cycling disrupt the laser beam output and the instantaneous alignment of the light collection optics.

Figure 1. The Raman lidar shelter at the SGP central facility.

Furthermore, during late summer the outside air temperature gets so warm that the air conditioning unit cannot keep pace. At times, the temperatures inside the shelter have become too hot for the laser components, causing them to fail. Component failure is an extra expense, and it results in loss of data until repairs can be made.

To eliminate these problems, a ventilation and air conditioning upgrade is being completed. All new ductwork and two air-handling units are being installed and weatherproofed (Figure 2). The more efficient system will moderate the temperature swings during the unit's on-off cycles and will handle the late summer heat better. These improvements will protect the lidar equipment so that it can provide valid, useable data streams.

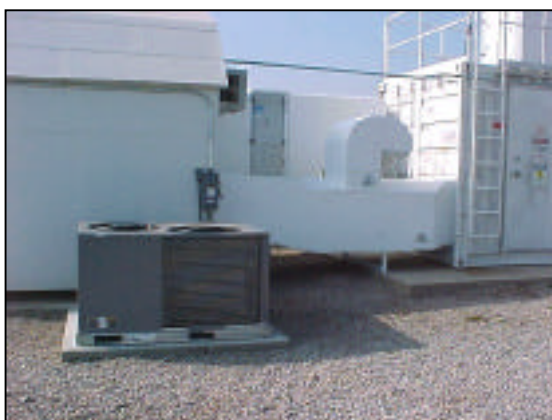
Figure 2. The new air conditioning unit and ductwork for the Raman lidar shelter.

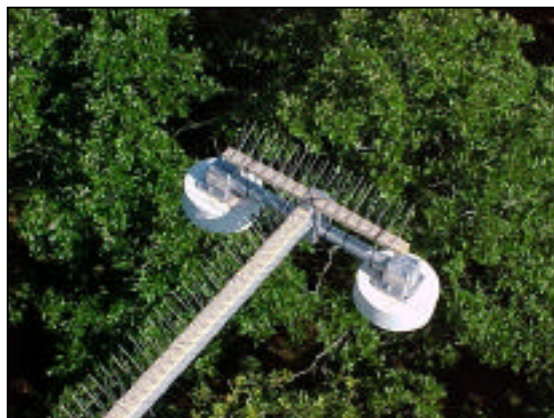
The instrument tower at Okmulgee State Park has been plagued with problems caused by turkey vultures using it as their perch. Vultures roosting on the

Figure 3. Bird spikes mounted to an instrument boom on the Okmulgee tower.

booms extending from the tower coat the instruments and the stairways below with droppings. Methods used in the past to make the tower less inviting include a sonic bird repeller that emits a turkey vulture distress cry, an inflatable red and yellow ball intended to frightening the birds, and a rotating wire fixed to the top of the tower. These devices were not very successful. The latest attempt at sending a "no roosting here" message to the vultures is the installation of bird spikes (Figure 3), upward-pointing metal pickets designed to eliminate open spaces for roosting. So far, this impediment has been successful.
